POST CONSTRUCTION SAFETY AUDITS: SEAL EXTENSIONS  
FINAL REPORT

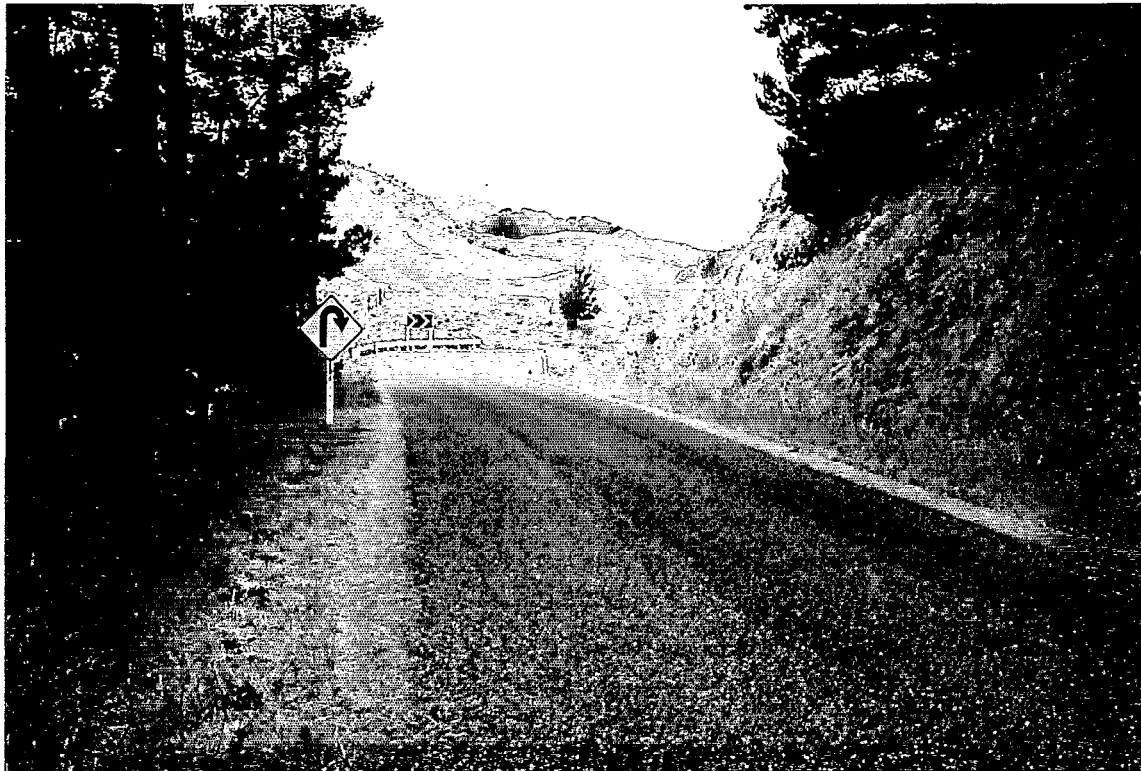
**PHOTO 9 - CURVE SIGNS/CHEVRONS/SIGHT RAILS**

Typical severe curve treatment. No advisory speed plate, two bar chevron, sight rail too short.

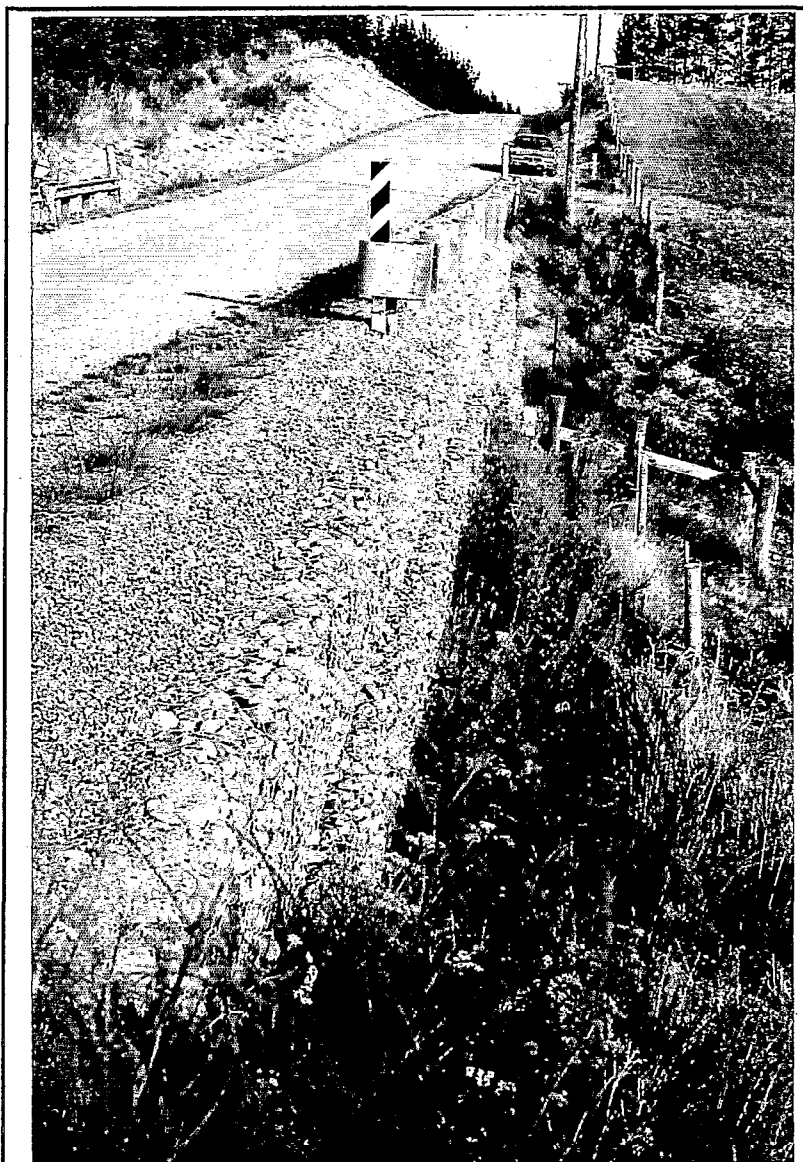
**PHOTO 10 - GUARD RAILING**

Several unsafe and poor examples of guard rail were identified. In a number cases it was considered the guard rails could not possibly achieve the intended purpose due to the manner in which they were installed. They were little more than an expensive sight rail.

- Posts installed on top of gabion walls within the top gabion basket.
- Situations where the finished level of the tops of gabion walls were up to 400-500mm below seal level. Timber planks had been placed on top of the gabion walls against the guard rail posts to retain the metal shoulder. This effectively increased the length of the post and the 'lever arm' from the standard 550mm to 950-1050mm above seal level significantly reducing the lateral resistance.

Note the guard rail posts are embedded in a gabion wall. The guardrail lacks sound anchorage and lateral restraint, has no flares and ends well short of the extent of the retaining wall.

*That Transfund require Road Controlling Authorities to undertake safety inspections of all guardrails to ensure that they are correctly installed.*

*That Transfund encourage Road Controlling Authorities/Consultants to provide additional training on the design and installation of guard railing.*

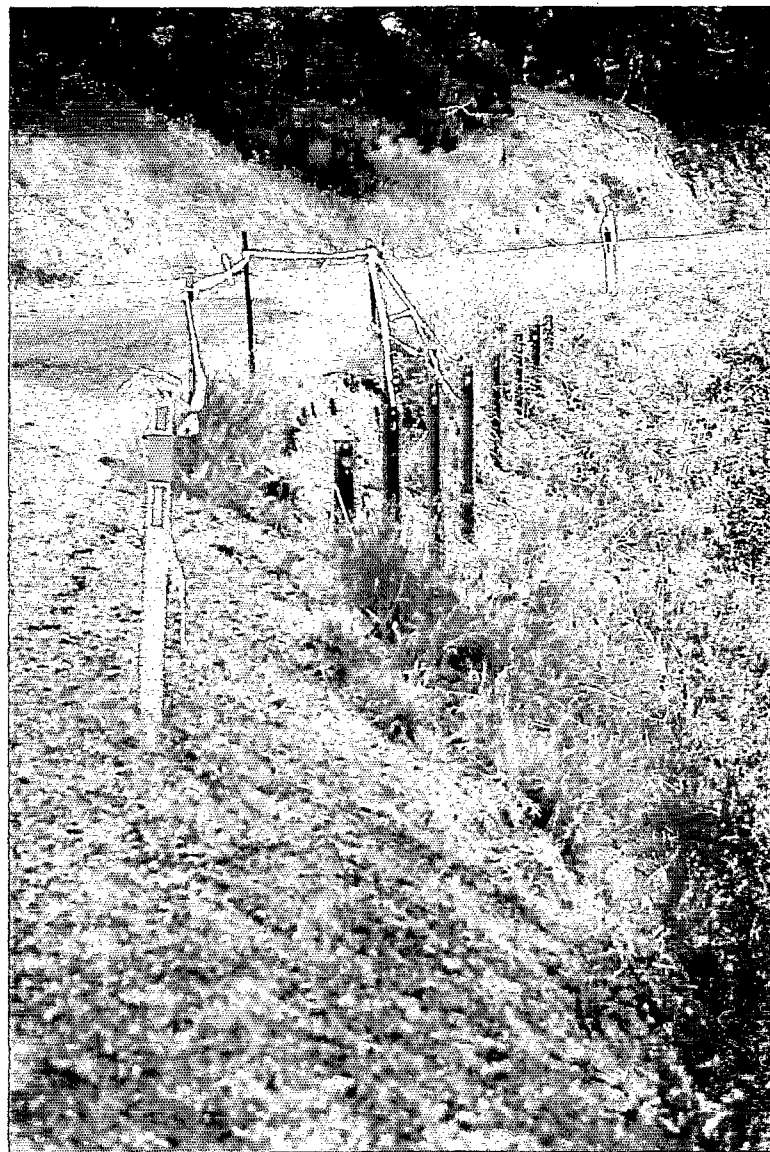
**PHOTO 11 - ROAD FAILURES**

On many projects significant dropouts had either occurred or are likely to occur. There was evidence of a lack of geotechnical investigation and/or poor engineering. Failures were obviously left unrepaired for long periods of time. Warning signs and forms of protection were generally inadequate as these failures often occurred where visibility was poor. In many cases orange mesh was the only warning provided and this had frequently faded to almost white.

Note poor delineation of dropout, also exposed steel rails.

*That Transfund require Road Controlling Authorities to undertake adequate geotechnical investigations to minimise the risk of future dropouts. This issue is discussed further in Section: 3.3 Scheme Assessments/Application for funding and Section: 3.4.6 Seal Extension Maintenance Costs.*

*That Transfund require Road Controlling Authorities to ensure that adequate warning of failures is provided. If funding is not immediately available more permanent warnings/fencing should be put in place until repairs are completed.*

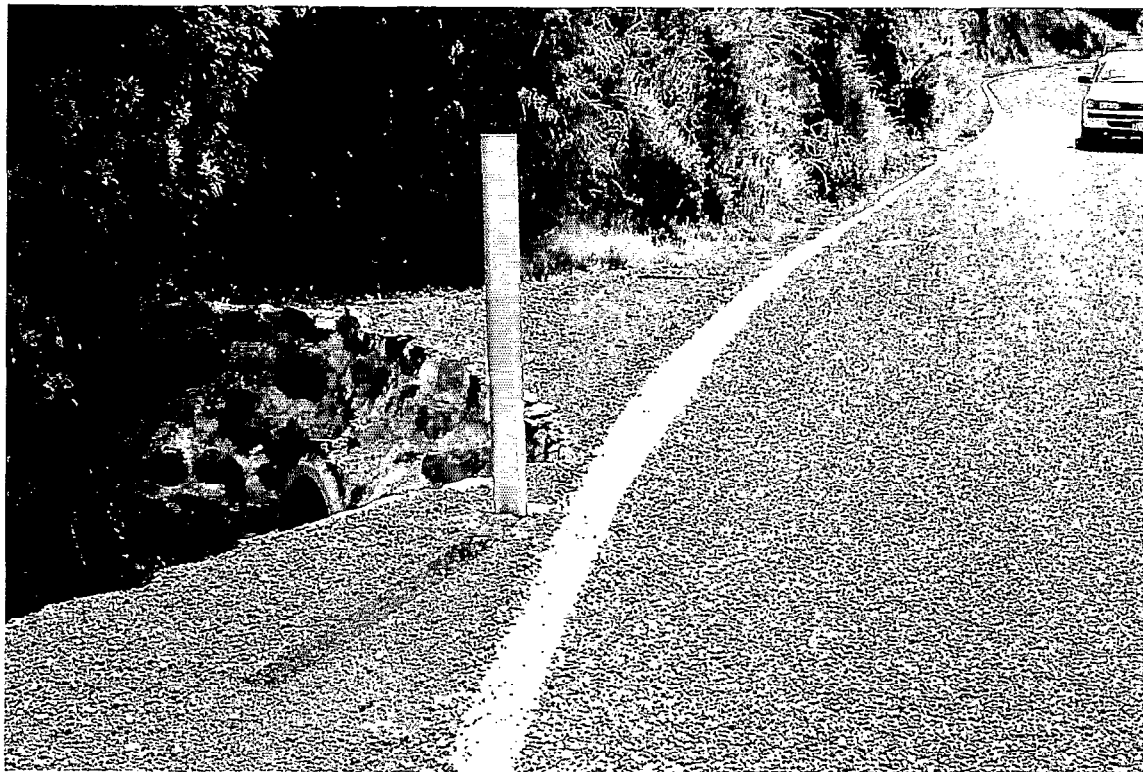
**PHOTO 12 - CULVERT END STRUCTURES**

There was little attention paid to safe treatment of culvert end structures. Many were very close to the edge of seal, unmarked or wrongly marked with marker posts, and often scouring/undermining of the seal had developed.

Note the proximity of the recently constructed culvert head wall, also the lack of a sight rail/hazard marker.

*That Transfund require Road Controlling Authorities to ensure culvert end walls are not constructed dangerously close to the edge of seal on new projects. If possible, culverts should be constructed flush with a 3 to 1 fill batter. Structures should be designed to minimise damage to errant vehicles which leave the road. Ideally a 2m feather edge should be accommodated, however, it is acknowledged that this is not always practicable.*

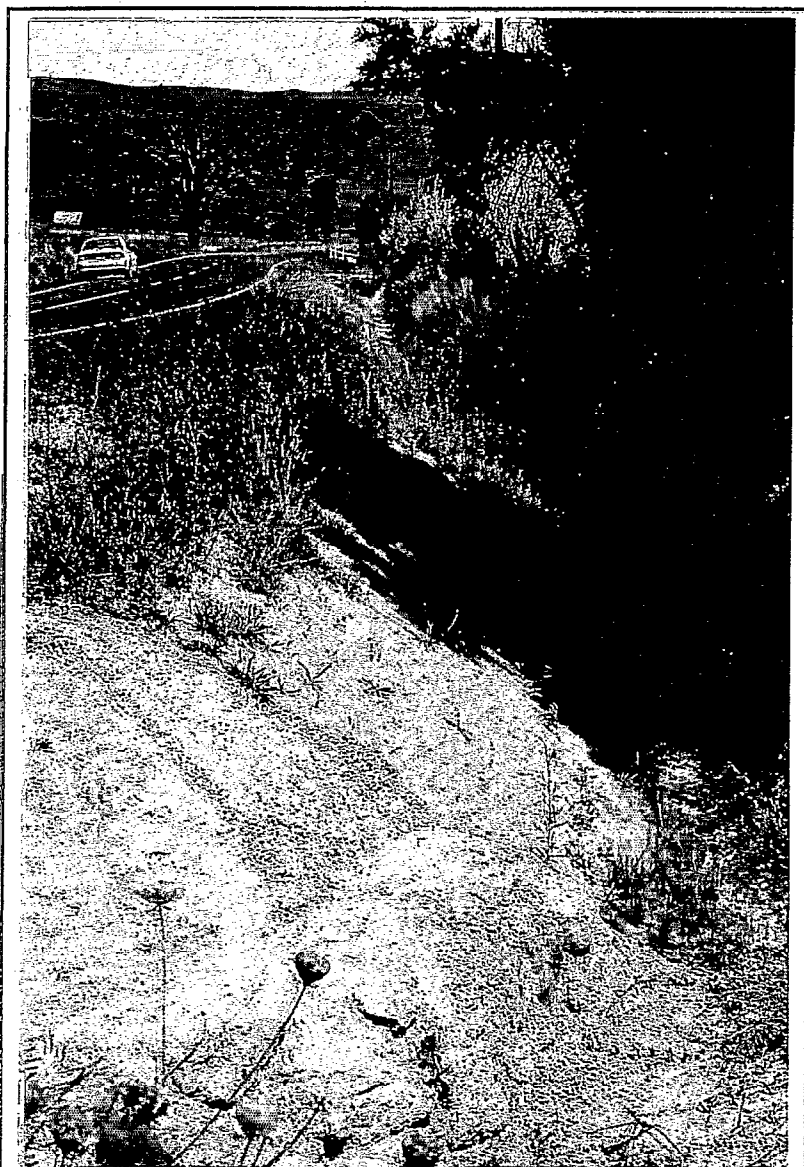
A number of projects had side drains which appeared unnecessarily deep. This may have been as a result of the overlay/shape correction incorporated in the seal extensions. Many were on steep slopes and erosion/undermining of the edge support was occurring. One project had excessively deep side drains adjacent to the road. This was apparently related to difficulties in finding an outlet and problems with the landowner.

PHOTO 13 - SIDE DRAINS  
Note depth of adjacent side drain

*Transfund should require Road Controlling Authorities to ensure that in general the depth of side drains not greater than that necessary to provide adequate drainage. Deep outlet drains should not be located adjacent to the highway.*

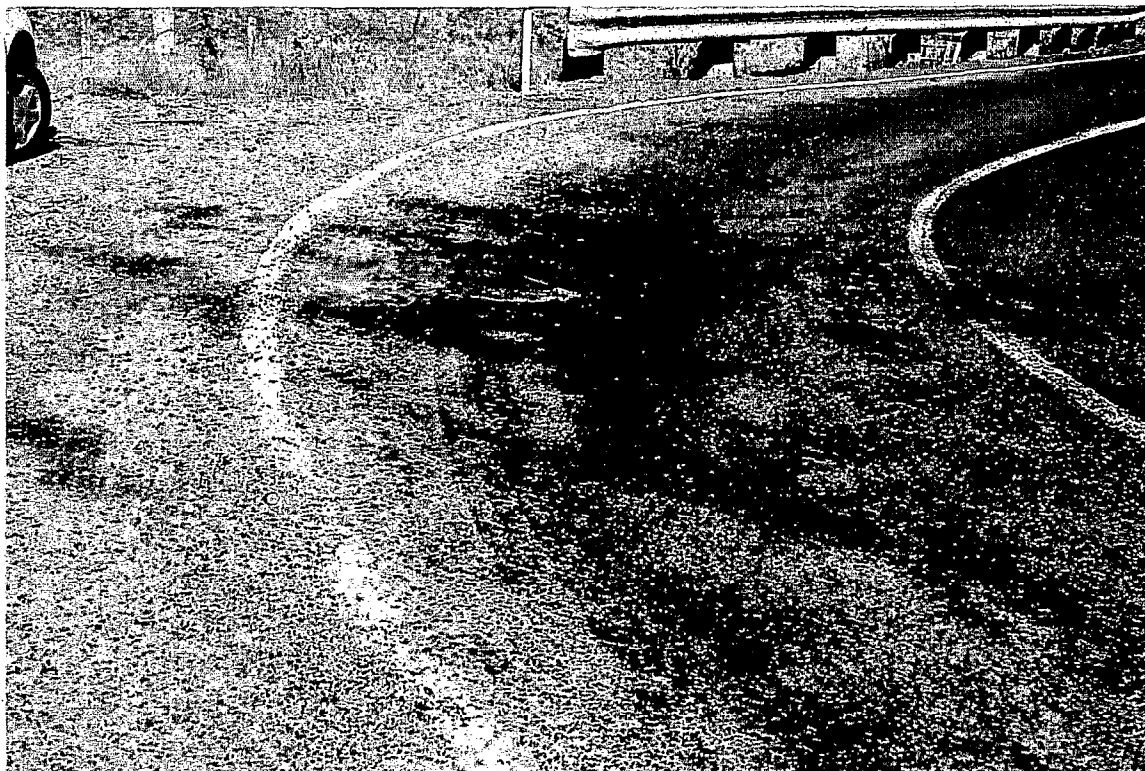
Several projects showed evidence of a deteriorating road surface and rapid loss of skid resistance. This was generally on tight curves with high traffic demand. The problem ranged from severe chip seal loss which in some cases had resulted in exposure of the base course, to sections of seal chip stripping.

PHOTO 14 - DETERIORATION OF SURFACE  
Note the bleeding, also to the left of the lane the basecourse is exposed.

*That Transfund require Road Controlling Authorities to review sealing methods for high demand areas and to ensure adequate maintenance to provide uniform skid resistance.*

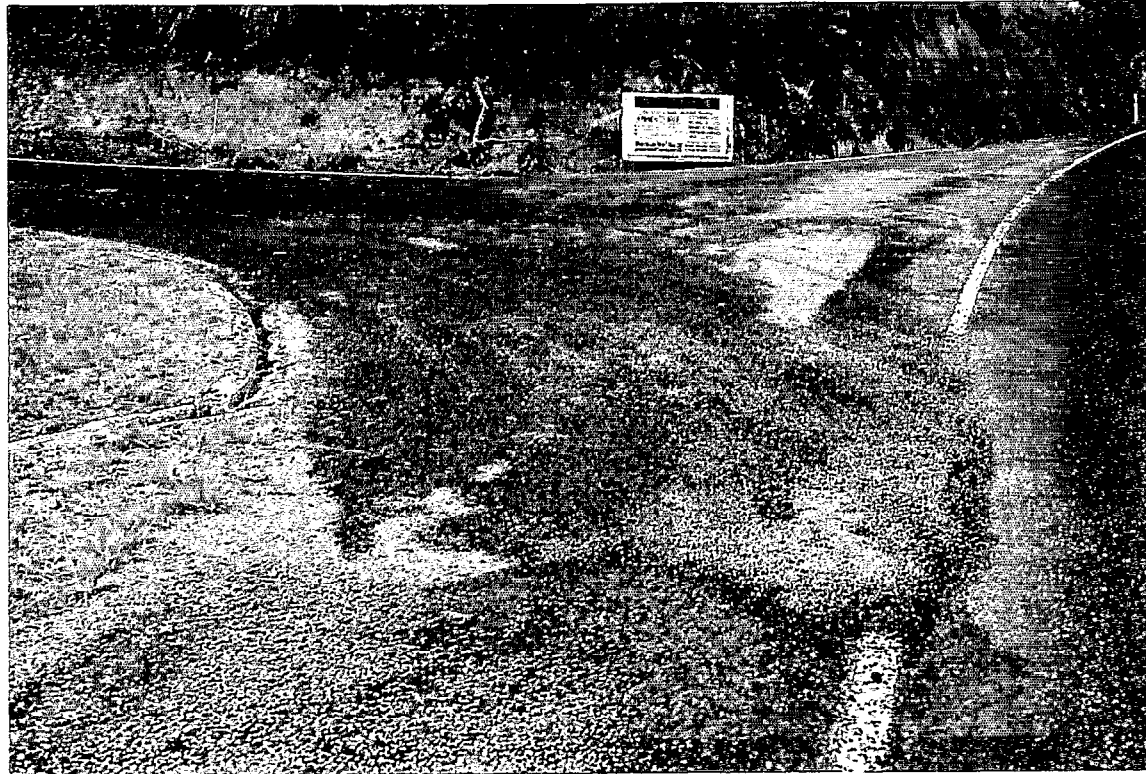
PHOTO 15 - LOOSE SEALING CHIP

Sweeping of loose chip appeared to have low or no priority with many Road Controlling Authorities. In many cases it appeared the surface had never been swept. Of most concern was the volume of loose chip noted on horizontal curves where it is considered particularly unsafe.

Note the sealing chip encroaching onto the lane, also the side road drainage is not being collected and flows across the highway.

*That Transfund require Roading Authorities to review road sweeping policies and to ensure the practice of failing to remove loose chip following sealing is eliminated.*
